Porter Creek Drainage

General characteristics

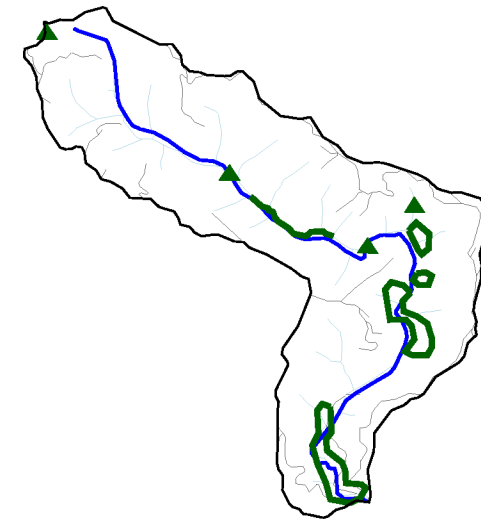
*Anadromous fish bearing streams*

*Potential problem culverts*

There are 22 points where roads cross over fish bearing streams
