# Condon Creek Drainage

## General characteristics

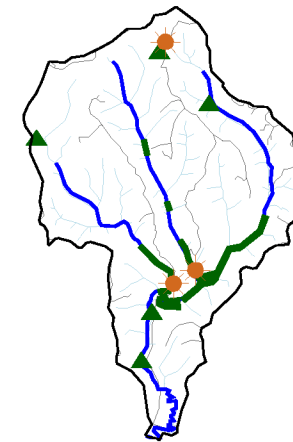
*Anadromous fish bearing streams*

*Potential problem culverts*

*There are 34 points where roads cross over fish bearing streams*
