Map 10.1 Potential Fish Passage Problems

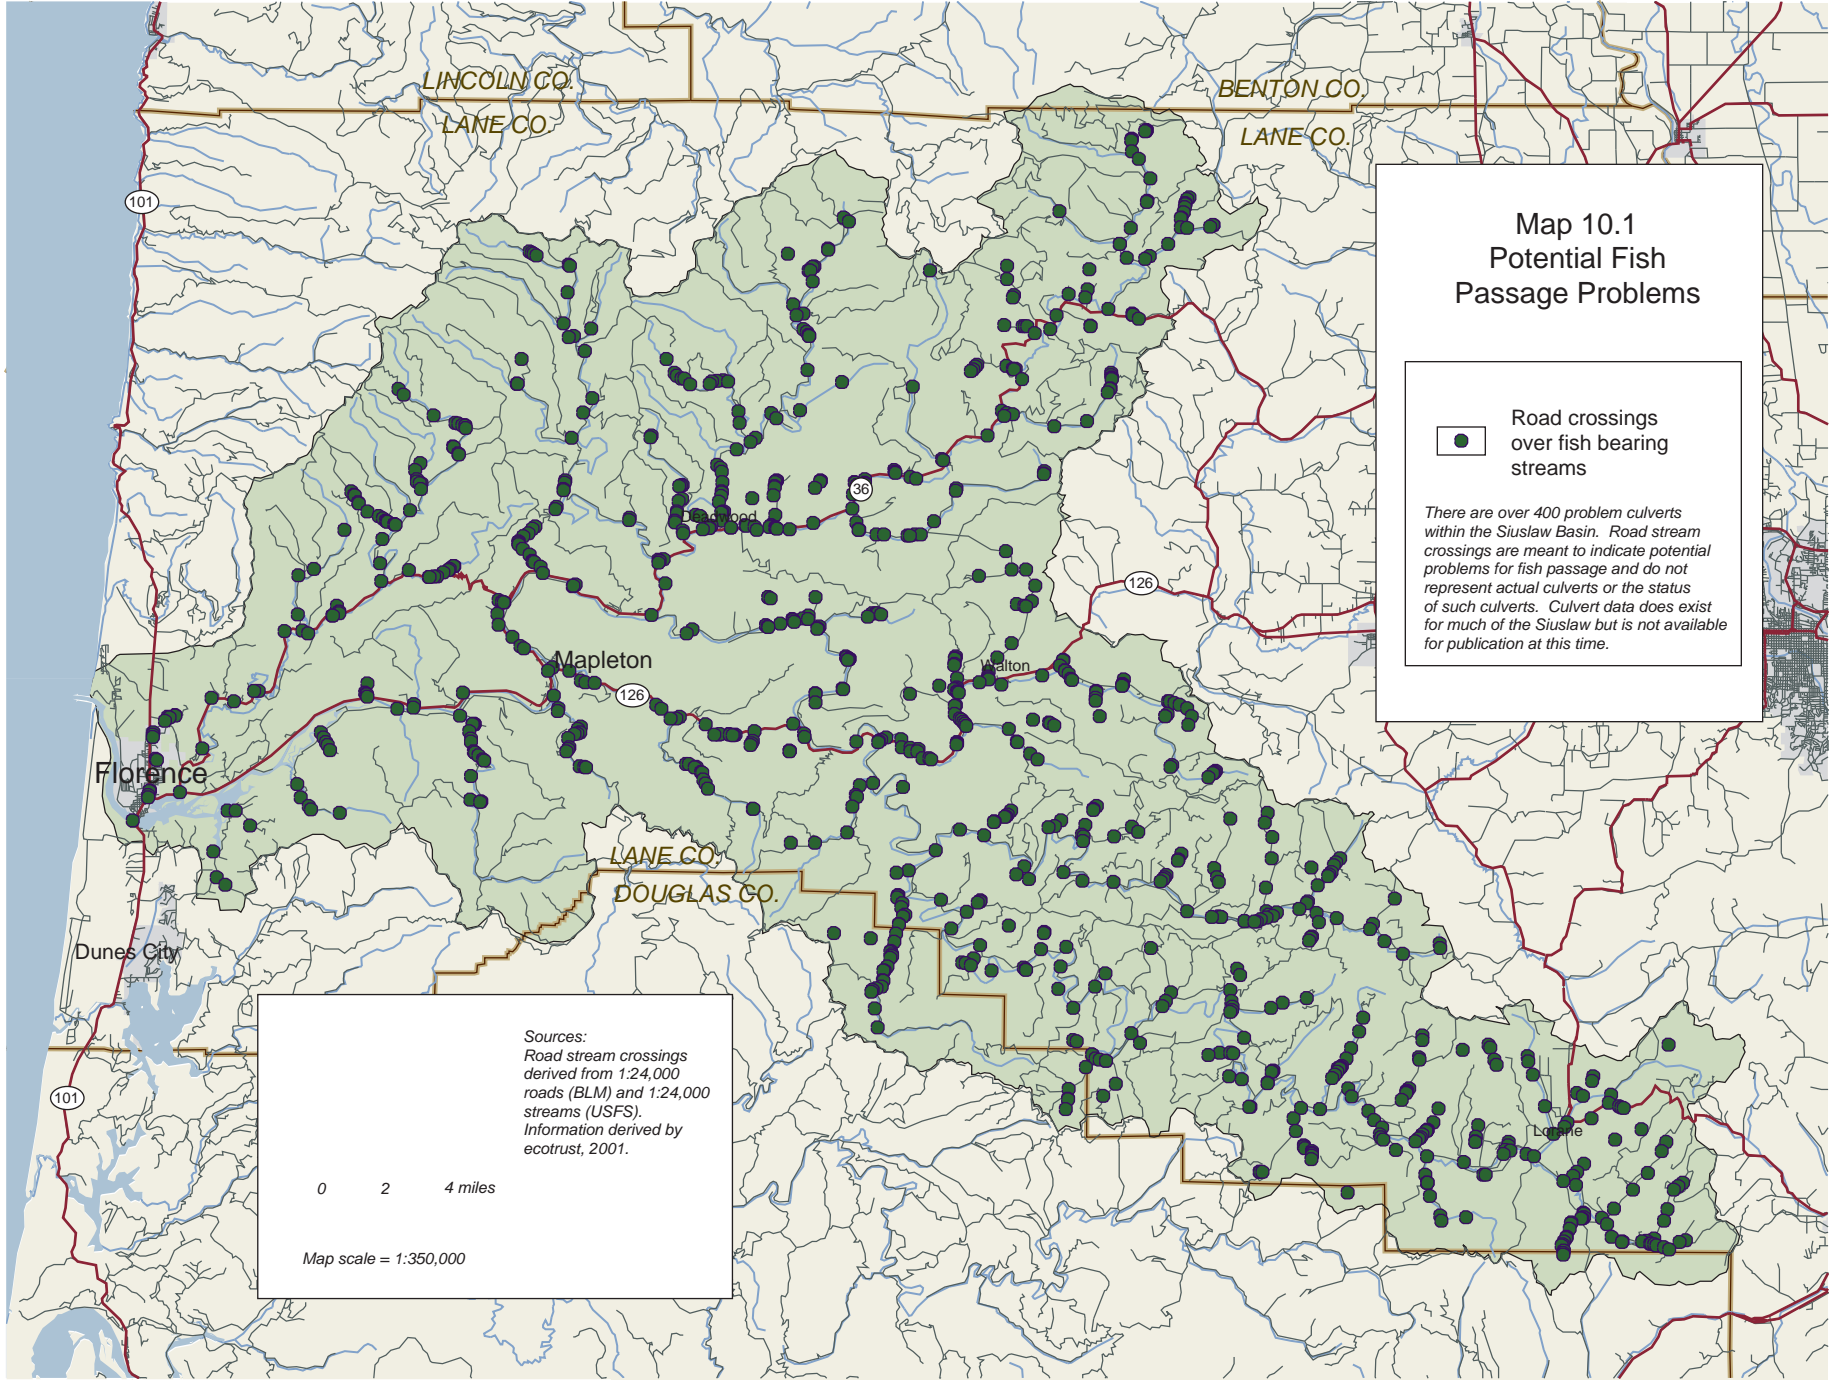
Road crossings
over fish bearing
streams

There are over 400 problem culverts within the Siuslaw Basin. Road stream crossings are meant to indicate potential problems for fish passage and do not represent actual culverts or the status of such culverts. Culvert data does exist for much of the Siuslaw but is not available for publication at this time.

Sources:
Road stream crossings
derived from 1:24,000
roads (BLM) and 1:24,000
streams (USFS).
Information derived by
ecotrust, 2001.
